TOWN OF HART'S LOCATION

REPORT: THREAT ANALYSIS FOR LOCAL WATER RESOURCE PROTECTION PLANNING

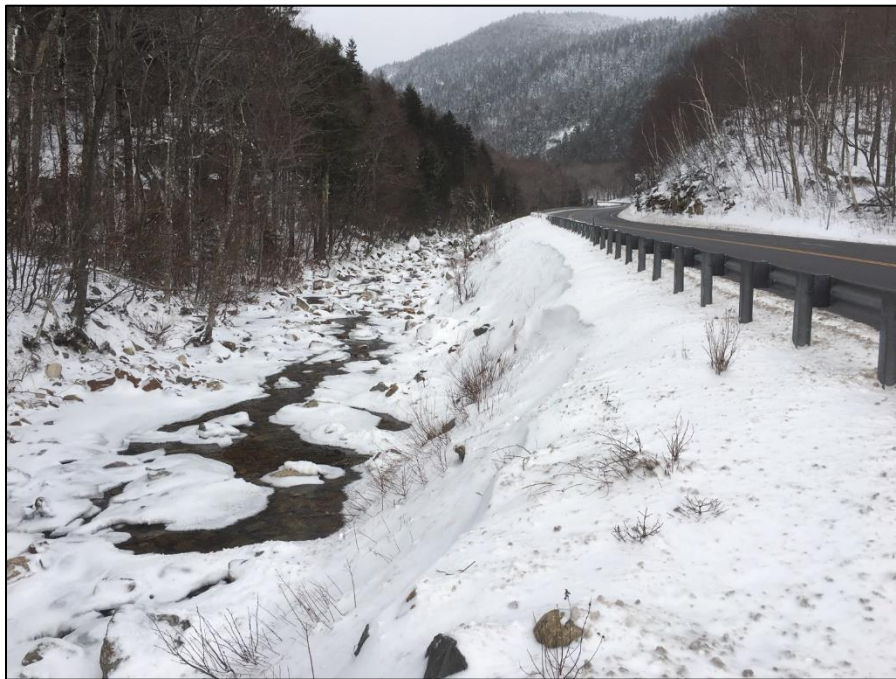
During the site visit in December 2020, FBE staff visually inspected this stretch of Route 302. Numerous places were identified where little buffer exists between the road and the Saco River (see example in Figure 4). The road is very close to the streambank, with very little room for natural vegetation to stabilize the bank. Riprap is instead relied upon for bank stabilization and armoring. These areas, where steep grade and little buffer coincide, are high risk for the export of sediment, nutrients, and chloride from the highway surface into the river with very little opportunity for vegetative buffering or infiltration into groundwater. Runoff transporting chloride (road salt) into rivers in the northeast is a large issue causing decreased water quality and habitat degradation (e.g., Kelly et al. 2019). These areas are also high risk for streambank erosion that could impact the roadway.

Figure 4: Location of little buffer between on US Route 302 and the Saco River, Hart's Location during winter conditions.

Establishing a buffer in this area would decrease the risk of chloride pollution and erosion from stormwater runoff, and would increase the resiliency of the streambank and the adjacent road to large storm events.

1. Consider establishing a vegetated buffer alongside the steep section of US Route 302 atop the east bank of the Saco near the northern town boundary.

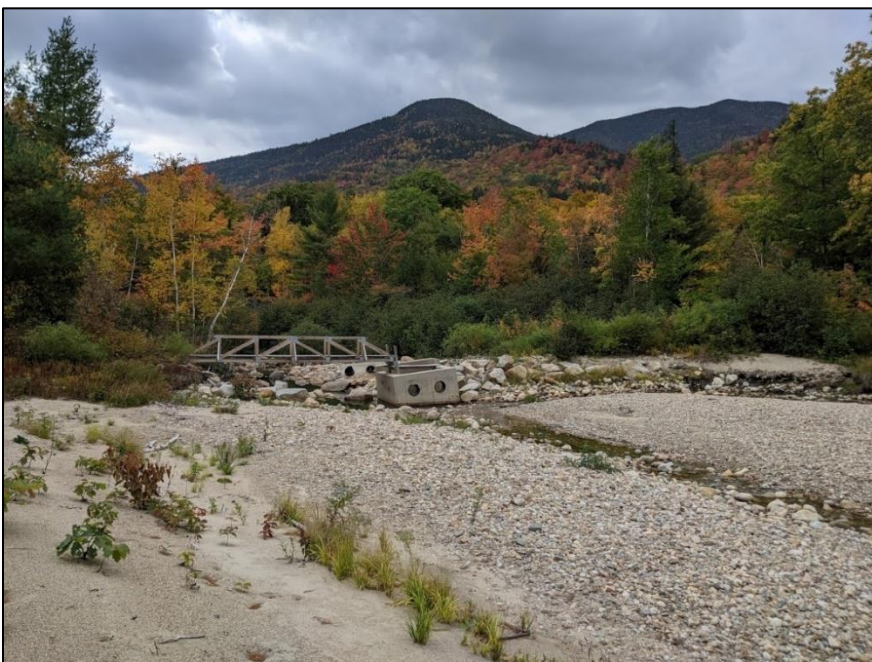
The current condition of the property is unstable and is at risk of erosion of the channel and banks. The dwelling on this property is well within the Saco's 100-year floodplain and very vulnerable to further impacts by large flooding events.

Figure 5: Secondary channel of the Saco River at the private property situated between Bemis Brook and the Saco main channel. The dam previously impounded streamwater into a reflection pond, but was destroyed by flooding in Tropical Storm Irene.

2. Work with private property owners in the floodplain to plan and design projects that protect water quality and promote flood resiliency. Emphasize good stream crossing design that is sized appropriately, promotes aquatic organism passage, will not overtop or flood in high flows, and is geomorphically appropriate for the setting.

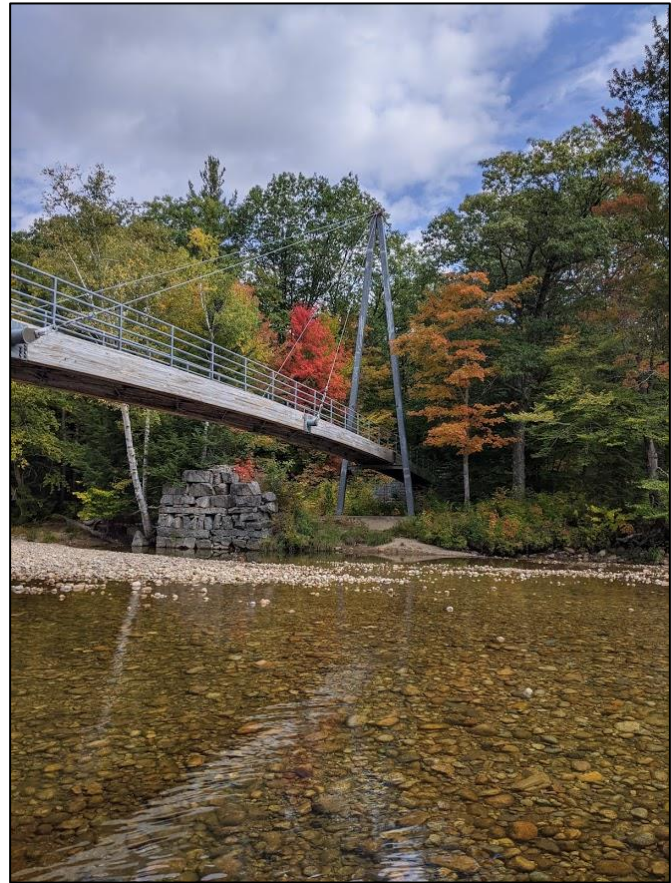
The Bemis Bridge appears to be in good condition with respect to erosion concerns around footings. There was no visible evidence of any impacts from tropical storm Irene or the October 2017 storm that would have caused any soil or bank instability, erosion, or sedimentation. The bridge received an aquatic organism passage (AOP) compatibility score of Full Passage and a geomorphic compatibility score of Fully Compatible (as reported by NHDES). This bridge is well designed for future flooding events and the historical evidence suggests that it is not at risk of damage or erosional processes from high flow events of the scale of recent decades.

Figure 6: Bemis Brook bridge over the Saco River.

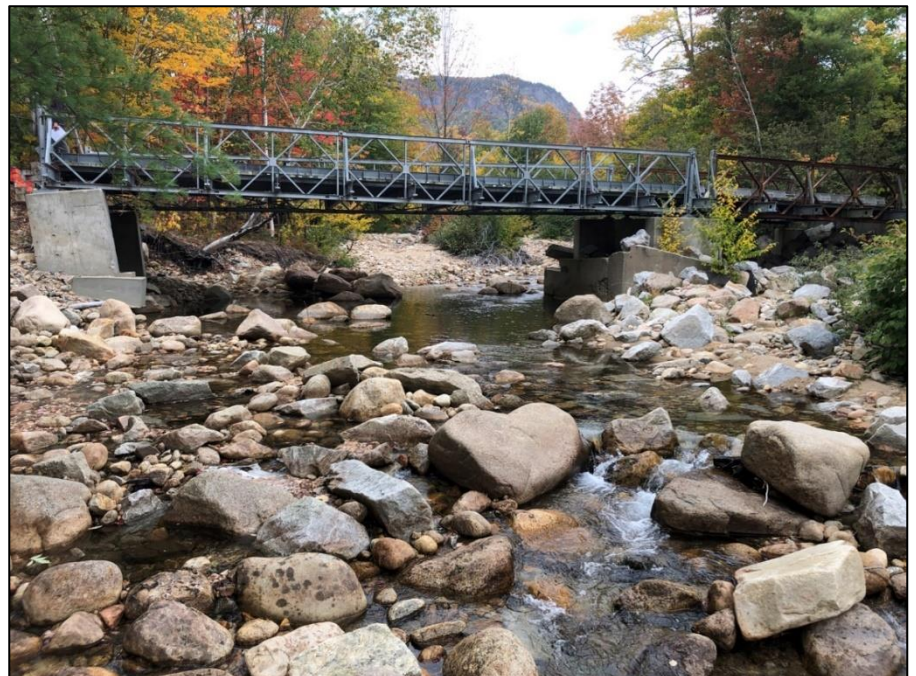
A small single car bridge with abutments crosses the Bemis Brook, connecting US 302 with a private property (discussed above). This bridge is currently in poor, unusable condition, with failing abutments and severe bank and channel scour on both sides of the bridge.

Figure 7: Failing Bridge over Bemis Brook providing access to private property.

organism passage compatibility score of Full Passage and a geomorphic compatibility score of Partially Compatible (as reported by NHDES). While fish passage is currently functioning, this bridge is at high risk of failure and additional streambank erosion in future flooding events. Bridge removal or replacement is recommended and FBE received a report that a replacement has been proposed.

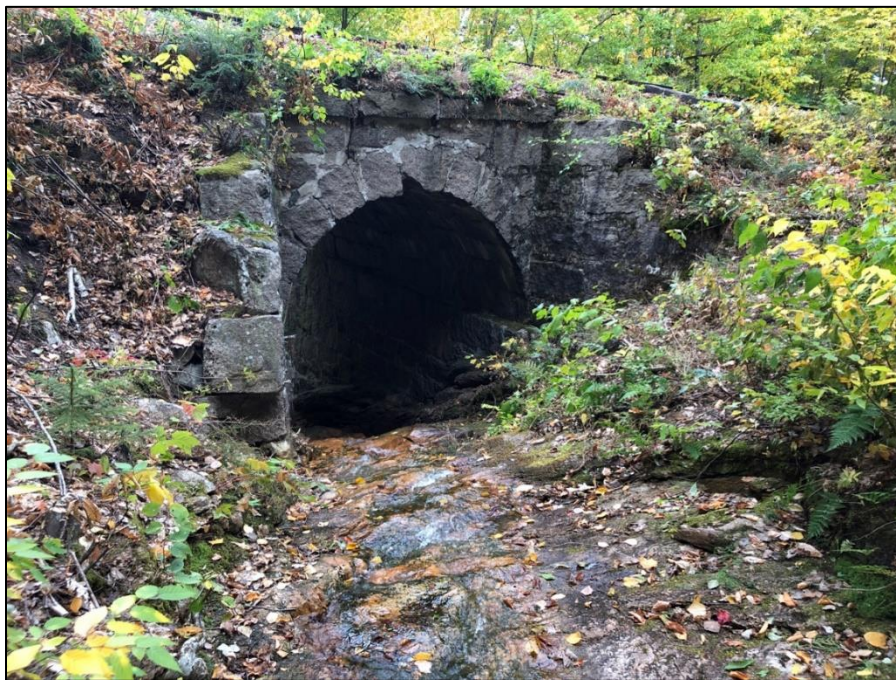
Kedron Brook flows from the mountains to the west of the Saco River and passes under the Conway Scenic Railroad and then Route 302 before entering the Saco. The railroad crosses Kedron Brook via a stone arch-bridge. This area of Kedron Brook has been identified as a predicted coldwater fishery.

The bridge received an aquatic organism passage compatibility score of Full Passage and a geomorphic compatibility score of Partially Compatible (as reported by NHDES). The bridge is in fair condition, with some undermining of the footers and wingwalls and some failing masonry. The downstream slope of the bridge is failing and eroding into Kedron Brook. Significant debris build-up is occurring on the downstream side of the bridge. Large cut stone blocks have tumbled into the channel and are obscuring the streambed, undoubtedly impeding the passage of aquatic organisms, despite the Full Passage score of the bridge itself. Furthermore, the failing slope is a risk of sediment inputs into Kedron Brook and the Saco River, especially during high flow events. Stabilization of the downstream bank of the crossing is recommended. FBE received a report that NHDOT has prioritized this trestle for rehabilitation or replacement.

The section of the Saco adjacent to the Kedron Brook railroad crossing does not yet have flood maps. It is likely that the crossing is situated above the Saco's 100-year floodplain. According to the hydraulic vulnerability model run by NHDES, the crossing is not at risk of being overtopped during a 100-year flooding event.

Figure 8: Kedron Brook Railroad crossing.

3. Restore the Kedron Brook flume abutments. FBE understands that a project is already proposed to accomplish this.
4. Consider a dam removal and ecological restoration project to remove the dam at the Willey House. Removing the dam would restore natural river processes to this reach of the Saco River, and could serve as a model for responsible dam decommissioning in mountain environments.

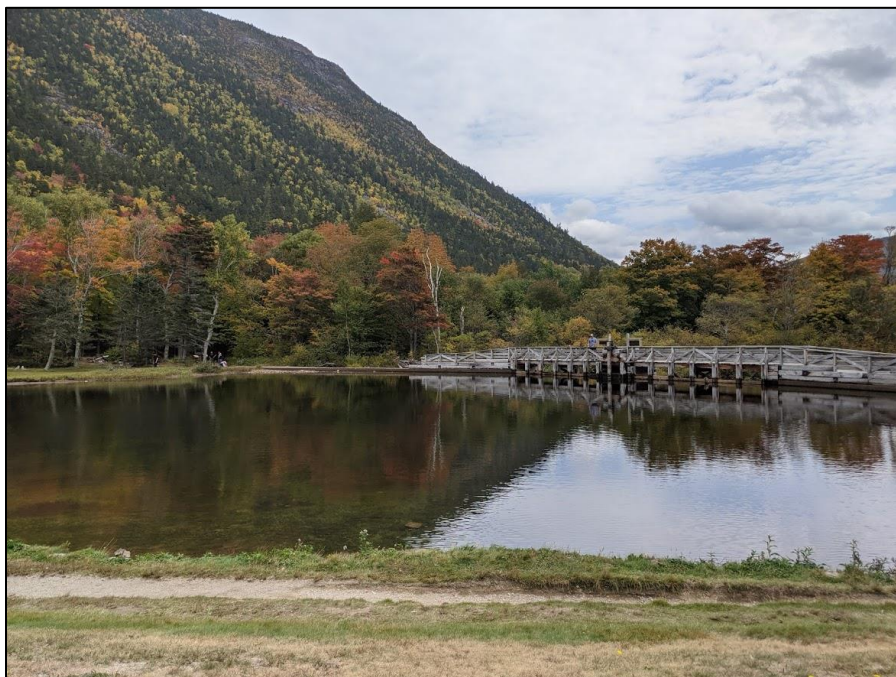
The dam appeared to be in good condition during the site visit in September 2020. Geese and ducks were present in the water and on shore, and field staff noted a significant quantity of waterfowl waste on the grassy shore areas adjacent to the reflecting pond. Artificial ponds that attract large numbers of waterfowl are potential sources of bacterial contamination above and beyond the background levels of fecal waste that would otherwise be present, sometimes exceeding safe levels.

The dam restricts fish passage and, though a detailed hydrologic study was not within the scope of this project, it is likely that the river's hydrology is severely altered both upstream and downstream due to the impoundment. Regular maintenance, including the dredging of sediment that has been deposited on the upstream side of the dam, is recommended in accordance with all applicable water quality protection measures and BMPs. Removal of this dam should be considered in order to restore natural river processes to this reach of the Saco River.

Figure 9: Dam and reflection pond at the Willey House on US Route 302, Hart's Location.
